NATIONAL TRANSPORTATION SAFETY BOARD

RAILROAD ACCIDENT REPORT

**REAR END COLLISION OF AN
ALASKA RAILROAD FREIGHT TRAIN
WITH A PASSENGER TRAIN**

**NEAR HURRICANE, ALASKA
JULY 5, 1975**

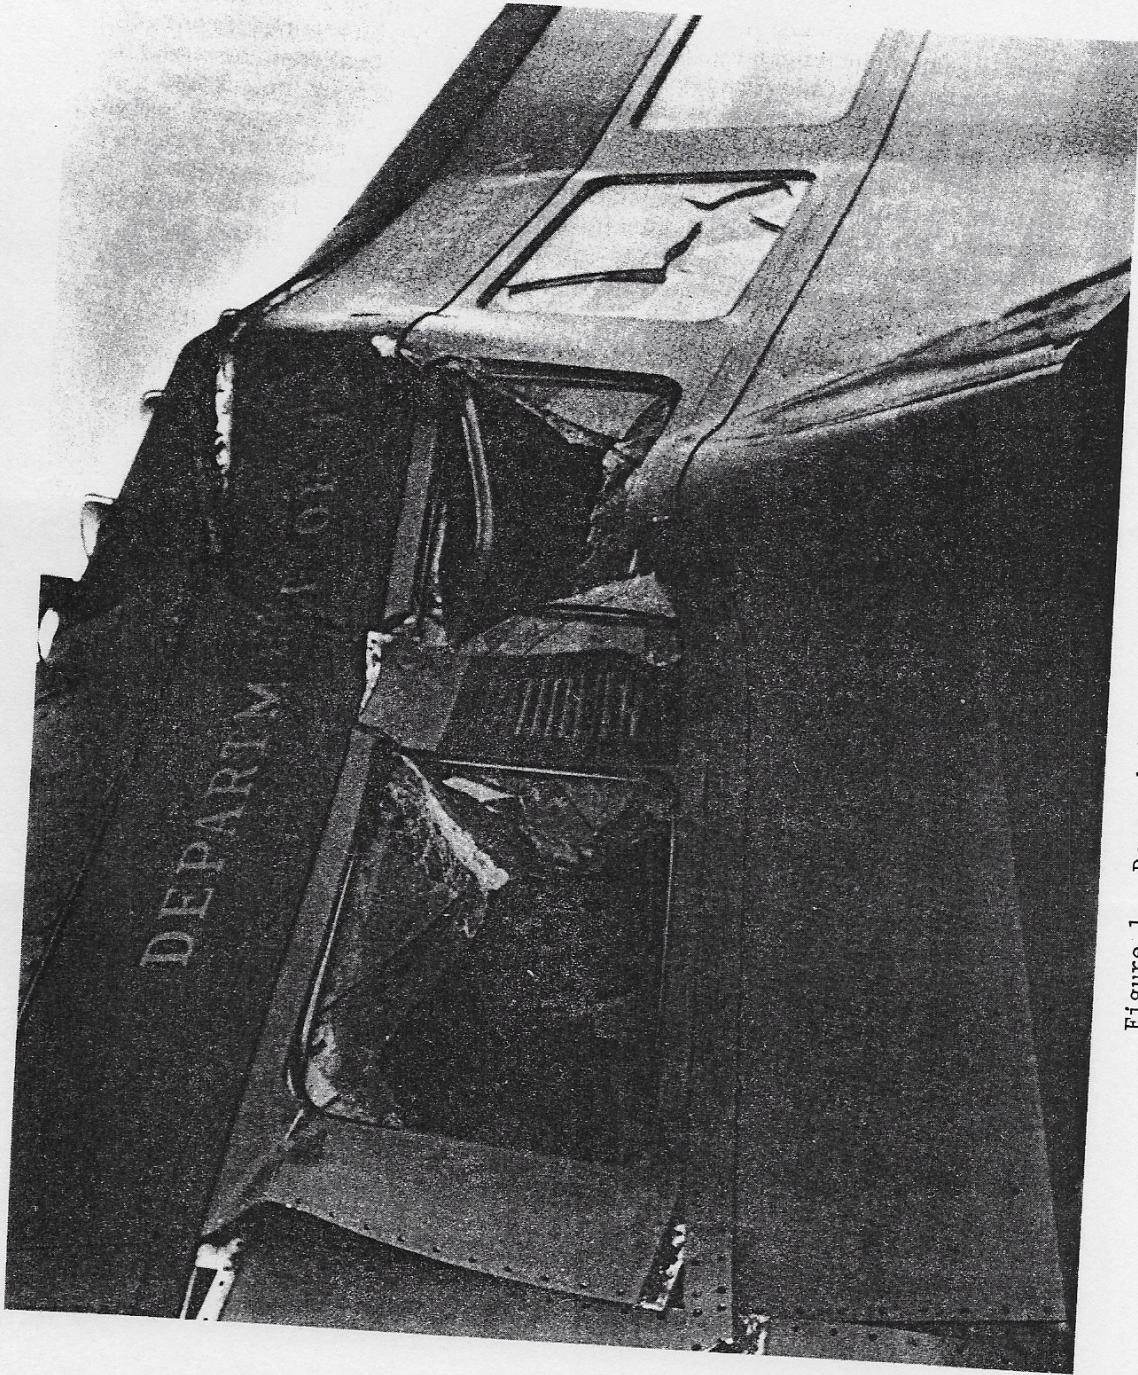
The rear of No. 5 stopped 76 feet south of the point of impact. All cars were derailed. Car 10, a dome car, was heavily damaged when the underframe buckled. (See Figure 1.) The remaining passenger cars were damaged slightly.

Figure 1. Damaged dome car of train No. 5.

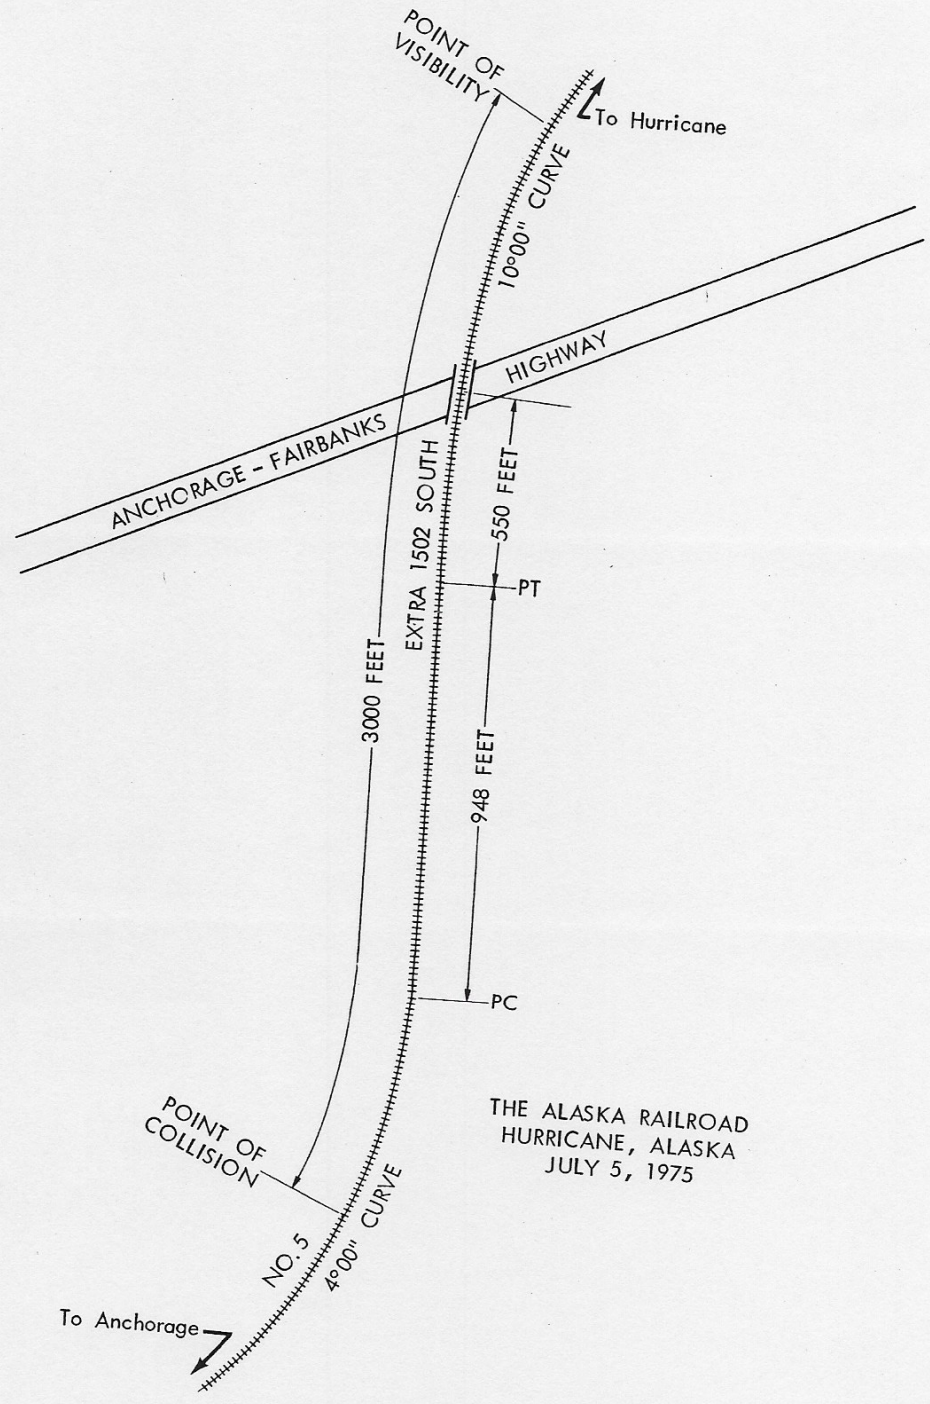
The single main track, south from Hurricane, is straight until a point 3,121 feet north of the collision. There, a 1° curve to the east extends southward 1,597 feet. The track is then straight for 948 feet, where a 4° curve to the west begins; the curve continues beyond the collision point. For southbound trains, the grade is 1.75 percent descending, from about the beginning of the 1° curve to the collision point. The Anchorage-Fairbanks highway crosses the main track 2,079 feet north of the collision point. (See Figure 2.)

Figure 2. Accident site.
